UNITED STATES DISTRICT COURT  
EASTERN DISTRICT OF MISSOURI  
EASTERN DIVISION

FRED NEKOUEE, individually, :  
: Plaintiff, :  
: vs. Case No. 4:19-cv-02735 :  
: HOA RESTAURANT HOLDER, LLC, :  
: a Delaware limited liability company, :  
: Defendant. :  
\_\_\_\_\_ /

**COMPLAINT**  
(Injunctive Relief Demanded)

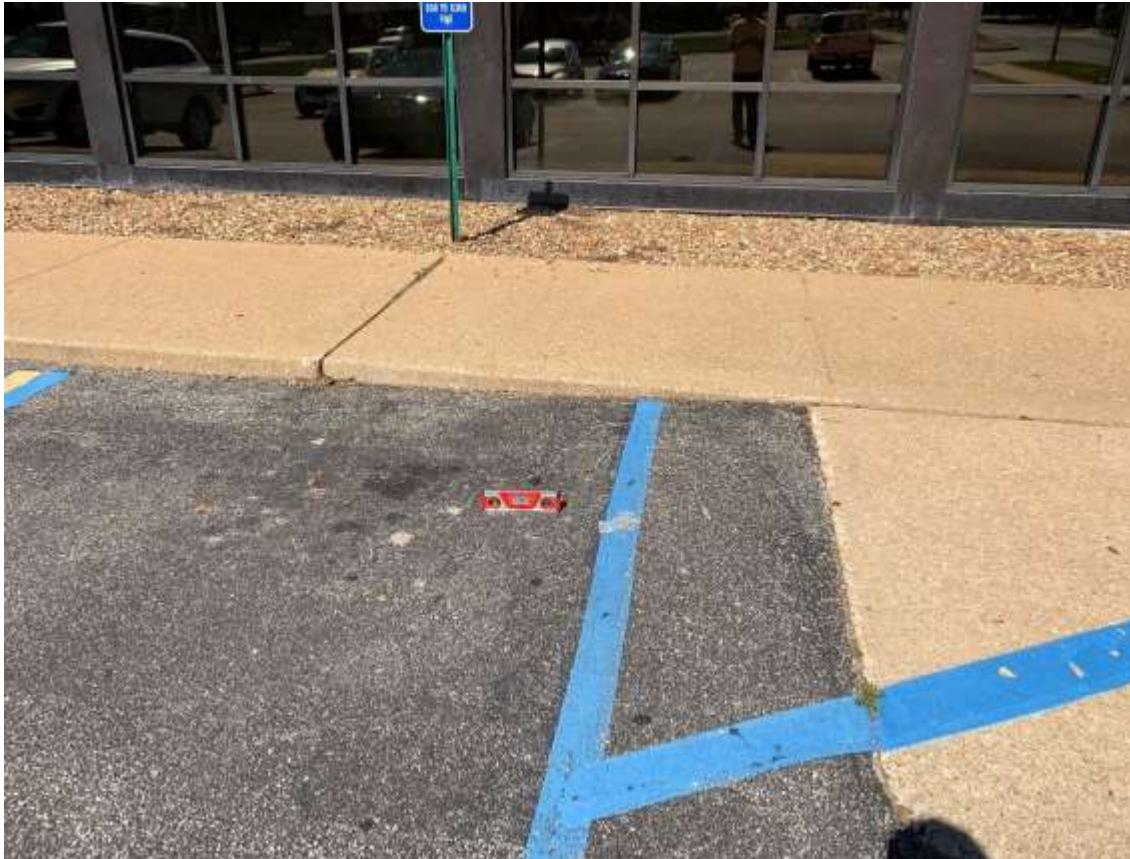
- b. (i) In the parking lot, the front section of the parking space (closer to the building) for disabled patrons shown in the photograph below is not even and has a cross slope that is steeper than 1:48 and steeper than 3.1%. (ii) The front section of this parking space for disabled patrons is not even and has a cross slope that is steeper than 1:48 and steeper than 3.5%, in violation of Federal Law 2010, ADAAG § 502.4. (iii) The cross slope in this parking space made the Plaintiff’s wheelchair unstable. (iv) The action required to reduce the cross slope of this parking space is easily accomplishable and able to be carried out without much difficulty or expense.

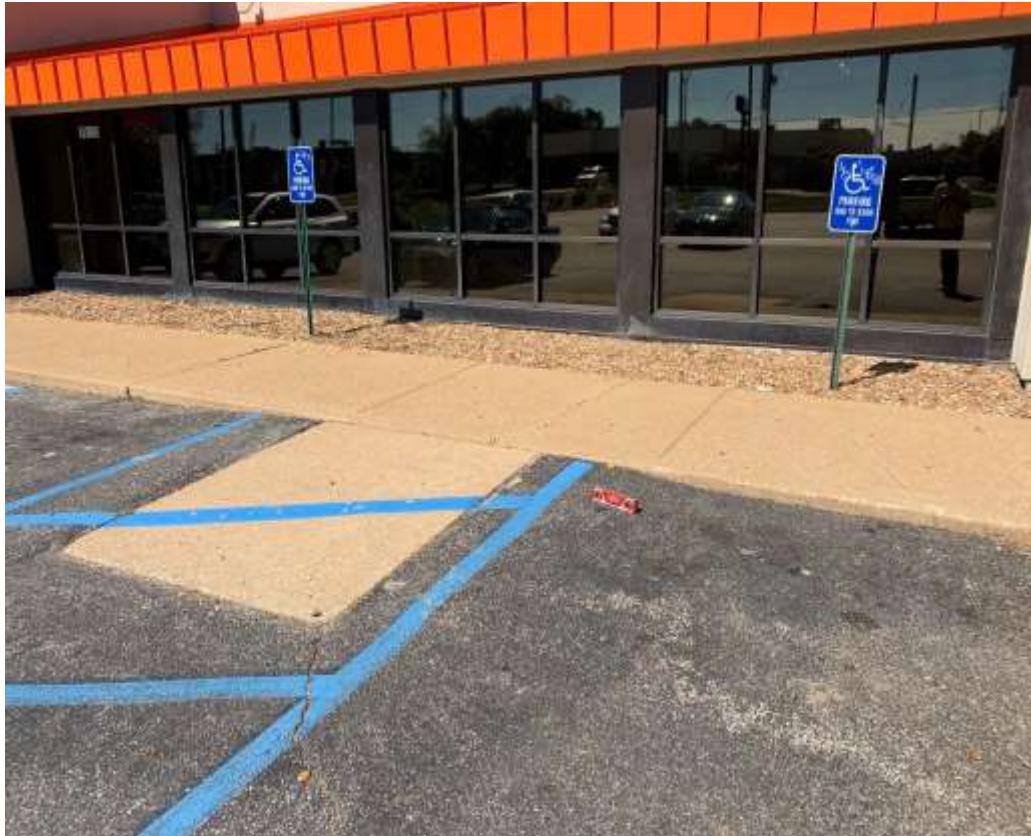
c. (i) In the parking lot, the front section (closer to the building) of the parking space for disabled patrons shown in the photograph below is not even and has a cross slope that is steeper than 1:48 and steeper than 3.1%. (ii) The front section of this parking space for disabled patrons is not even and has a cross slope that is steeper than 1:48 and steeper than 7.0%, in violation of Federal Law 2010, ADAAG § 502.4. (iii) The cross slope in this parking space made the Plaintiff's wheelchair unstable. (iv) The action required to reduce the cross slope of this parking space is easily accomplishable and able to be carried out without much difficulty or expense.

1. (i) The curb ramp shown in the photograph in subparagraph (c) above projects into the parking access aisle. (ii) This curb ramp projects into the parking access aisle, in violation of Federal Law 2010, ADAAG § 406.5. (iii) The Plaintiff used this curb ramp in this access aisle while moving in his wheelchair, and it made his wheelchair unstable

and it put him in danger. (iv) The action required to relocate this curb ramp is easily accomplishable and able to be carried out without much difficulty or expense.

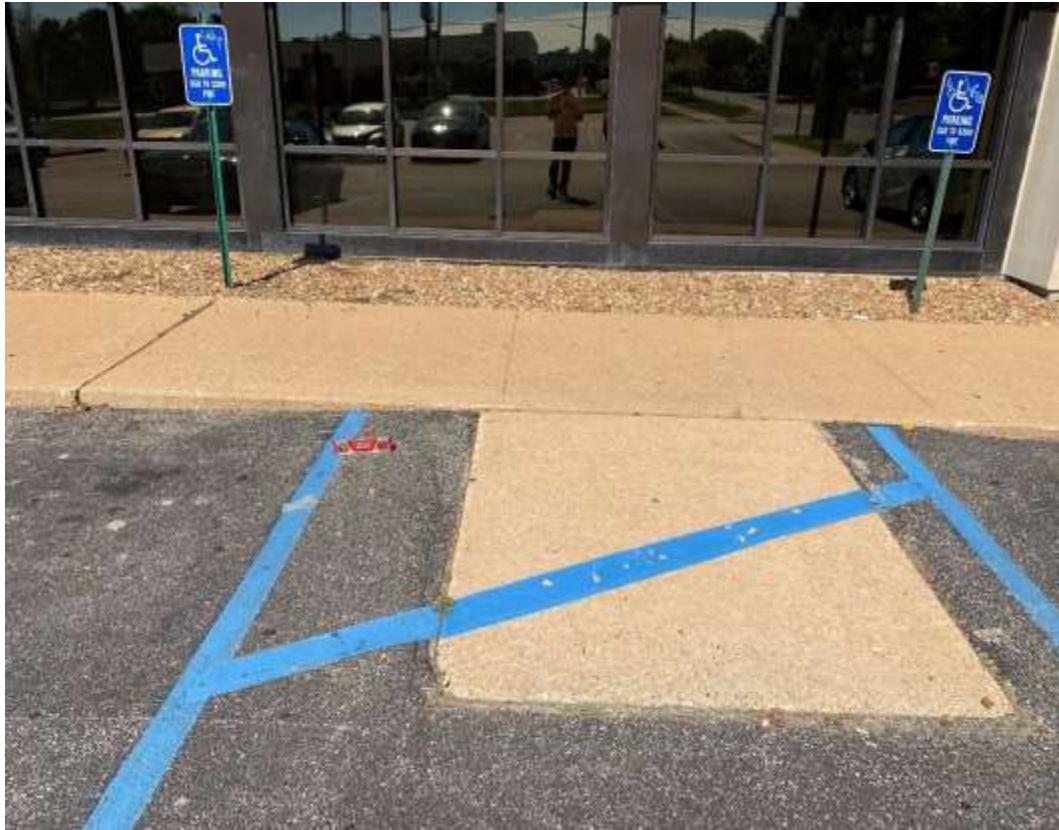
d. (i) In the parking lot, the front section (closer to the building) of the access aisle shown in the photograph below is not even and has areas with a cross slope steeper than 1:48 and steeper than 3.1%. (ii) The front section (closer to the building) of this access aisle is not even and has areas with a cross slope steeper than 1:48 and as steep as 1:16.4 (6.1%), in violation of Federal Law 2010, ADAAG § 502.4. (iii) The Plaintiff encountered steep cross slopes in this access aisle while moving in his wheelchair, and the steep slopes made his wheelchair unstable. (iv) The action required to level this access aisle and to reduce the cross slopes in this access aisle is easily accomplishable and able to be carried out without much difficulty or expense.

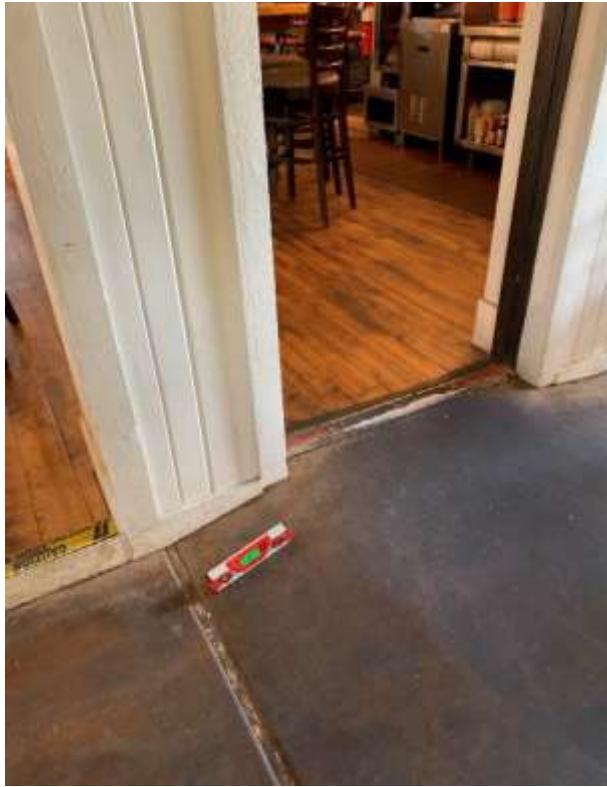
p. (i) In the back section of the restaurant, the side of the ramp shown in the photograph below has a slope steeper than 1:10 (10%) and steeper than 11%. (ii) The side of this ramp has a slope steeper than 1:10 (10%) and as steep as about 18%, in violation of Federal Law 2010, ADAAG § 406.3. (iii) The Plaintiff encountered this side of this ramp, and it caused his wheelchair to become unstable and slip sideways.

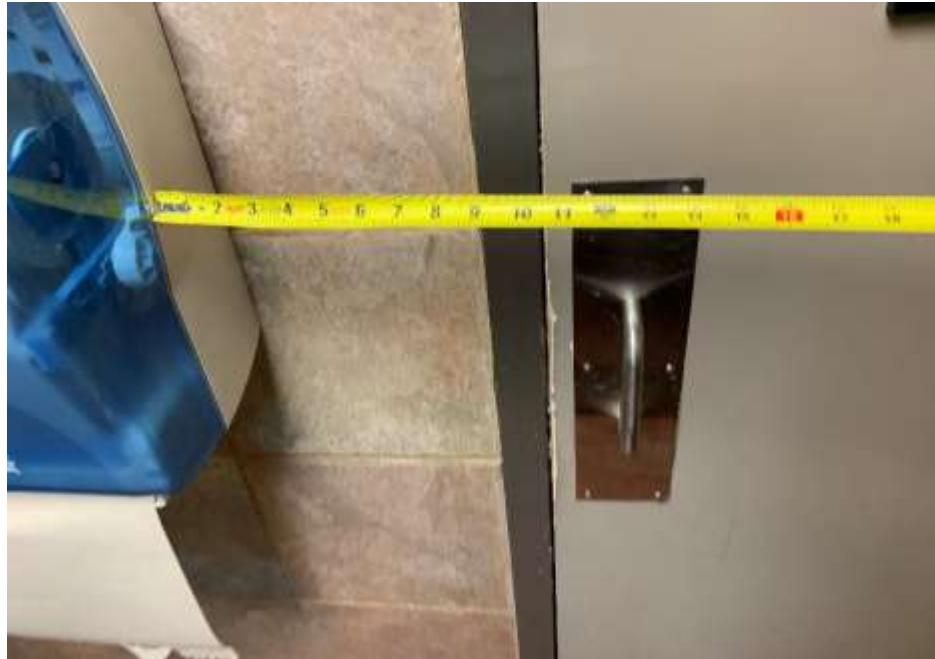
t. (i) The men's restroom door pull side maneuvering clearance in a front approach beyond the latch and parallel to the doorway is less than 18 inches. (ii) As shown in the photograph below, the men's restroom door pull side maneuvering clearance in a front approach beyond the latch and parallel to the doorway is about 10 inches and less than 18 inches since it is blocked by a wall-mounted paper towel dispenser, in violation of Federal Law 2010, ADAAG § 404.2.4. (iii) Due to the location of the wall-mounted paper towel dispenser parallel to the doorway, the Plaintiff had difficulty trying to open this door to exit the men's restroom, and he required assistance to exit the men's restroom. (iv) The action required to increase this pull side maneuvering clearance by relocating the paper towel dispenser is easily accomplishable and able to be carried out without much difficulty or expense.

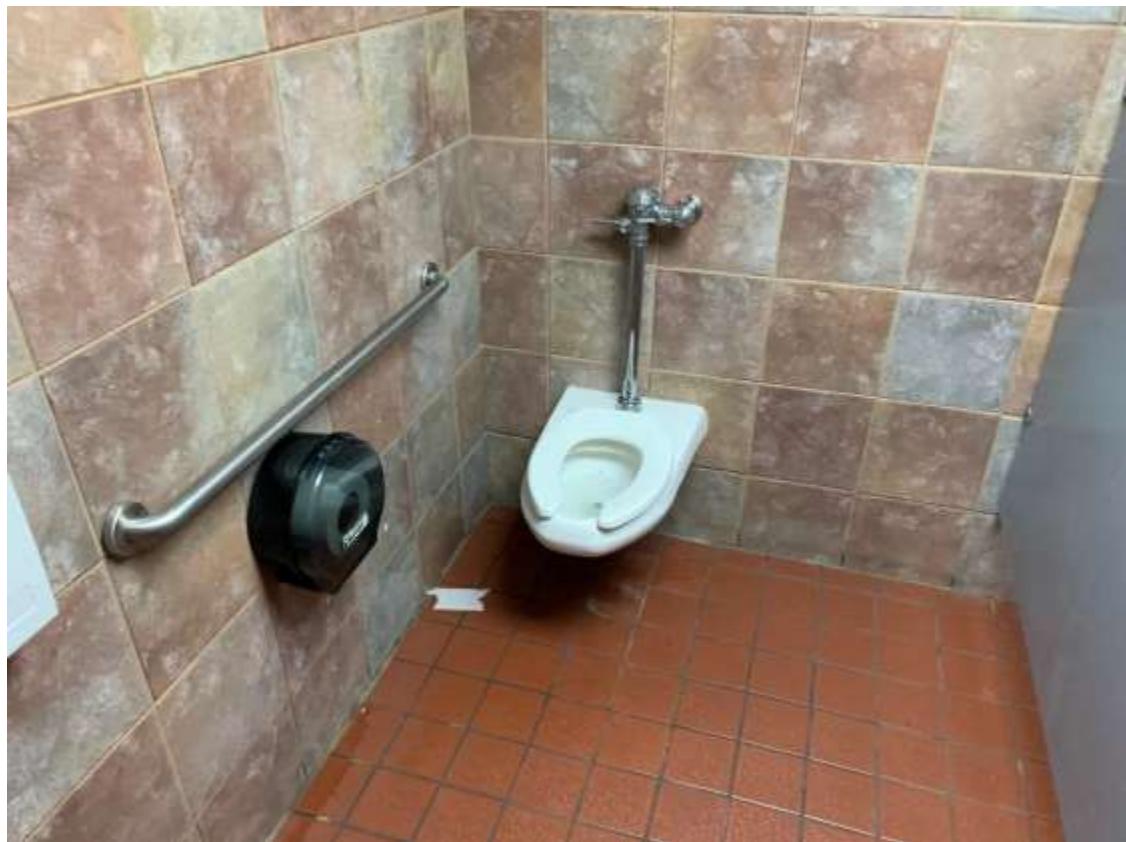
w. (i) As shown in the photograph below, the accessible toilet compartment in the men's restroom does not have a rear wall grab bar. (ii) The accessible toilet compartment in the men's restroom does not have a rear wall grab bar, in violation of Federal Law 2010, ADAAG § 604.5. (iii) Due to the lack of a rear wall grab bar in the accessible toilet compartment, the Plaintiff required assistance to transfer himself from his wheelchair to the toilet. (iv) The action required to install a rear wall grab bar is easily accomplishable and able to be carried out without much difficulty or expense.

bb. (i) In the men's restroom, the toilet's flush control is not mounted on the open and wide side of the clear floor space. (ii) As shown in the photograph in subparagraph (w) above, the flush control is not mounted on the open and wide side of the clear floor space of this toilet, in violation of Federal Law 2010, ADAAG 604.6. (iii) Due to the location of this flush control, the Plaintiff could not flush this toilet from his wheelchair. (iv) The action required to replace or move this flush control is easily accomplishable and able to be carried out without much difficulty or expense.
